NATIONAL TRANSPORTATION SAFETY BOARD

Investigator-in-Charge Factual Report

Type: Collision

NTSB #: DCA19FM033

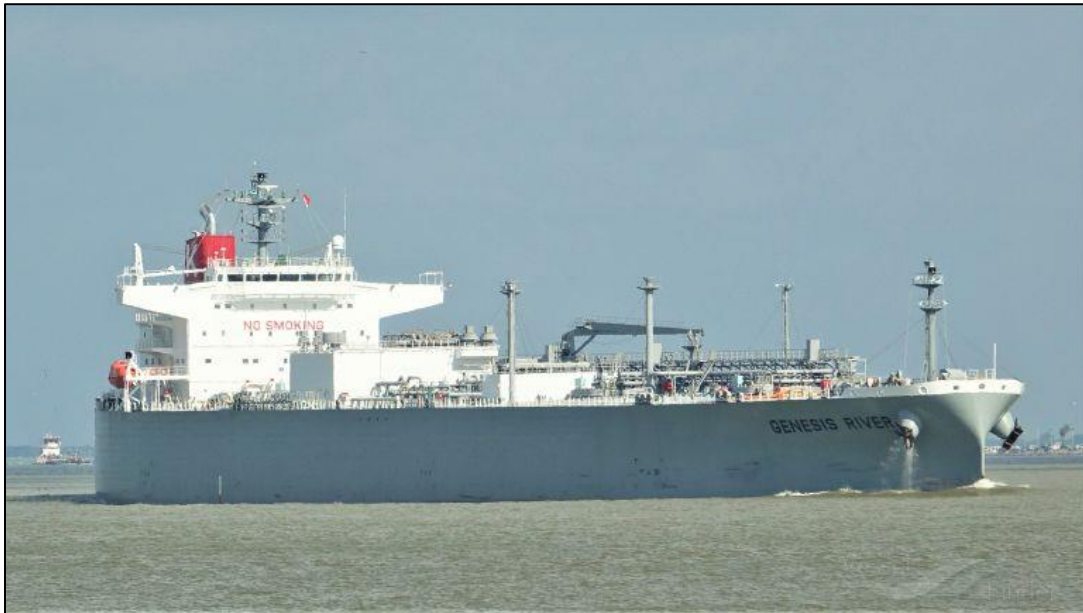
Figure 3. *Genesis River* under way in Bolivar Roads near Galveston, Texas, two weeks after the accident. (Source: William J. Leach, Jr.)

The collision opened an S-shaped gash in the *Genesis River* hull about 7.5 feet (2.3 m) below the waterline and 36 feet (11 m) aft of the bow on the starboard side, causing the vessel's fore peak tank to flood. The estimated cost of repairs to the *Genesis River* was \$406,000.

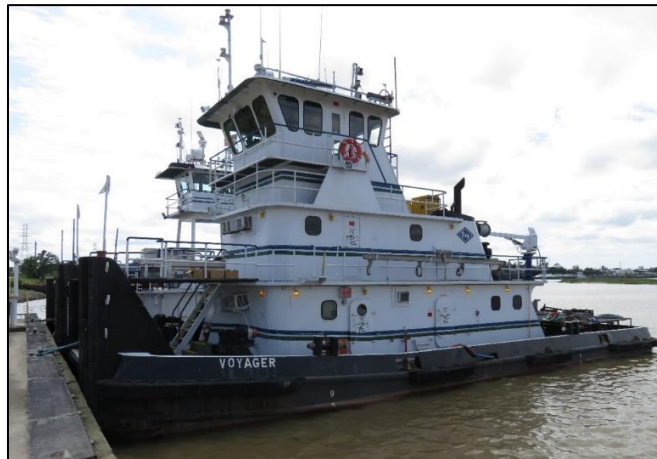
Figure 4. *Voyager* moored in Channelview, Texas, following the accident.

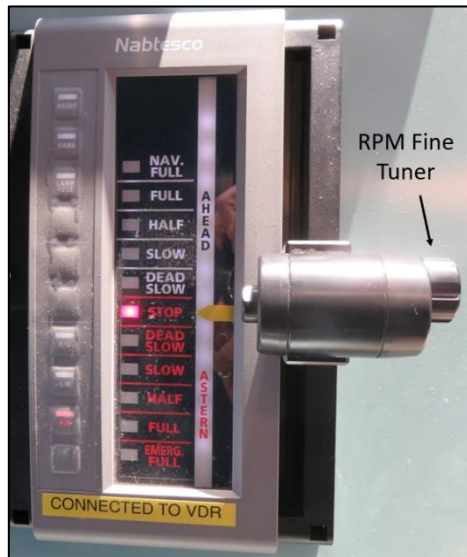
Figure 12. *Genesis River* bridge EOT lever.

detents stopped the lever at set rpm speeds for each standard engine order. A fine tuner dial on the side of the lever allowed the user to then make small adjustments to the rpm. In normal practice while in maneuvering mode, the fine tuner was not utilized, and the telegraph operator moved the lever to the detented position corresponding to the given order.

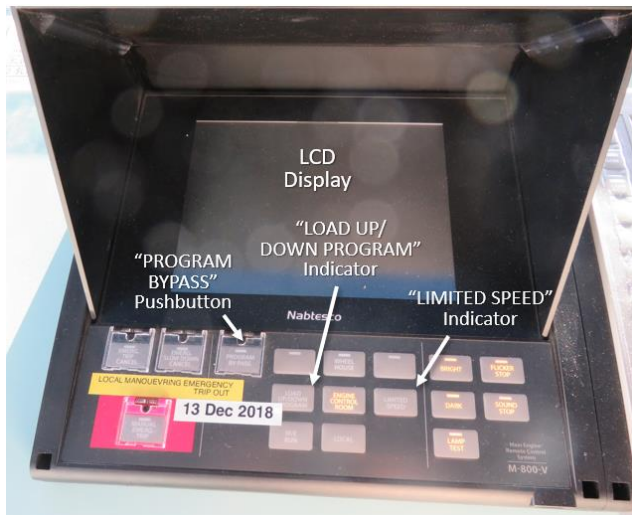
Figure 13. *Genesis River* bridge control panel for remote engine control system

The control panel for the system included a liquid crystal display (LCD) and several illuminated pushbutton switches. The LCD provided various system parameters, such as engine rpm and start air pressure, as well as alarm indications in the case of a system malfunction. When engine speed was changed, the rpm value of the ordered speed was displayed on the LCD. The pushbutton switches initiated various normal and emergency actions, such as starting and stopping the engine, and shifting control of the engine between the engine room, ECR, and bridge.

The control program function was to protect the engine against overload conditions and avoid of high thermal stresses and excessive vibration. When in effect, a “LOAD UP/DOWN PROGRAM” indicator illuminated on the system control panels on the bridge and in the ECR. Depending on the ordered rpm and the load on the engine, it could take up to 40 minutes under the load program to reach an ordered rpm in Nav. Full, according to the *Genesis River* chief engineer. (When the *Genesis River* increased speed to Nav. Full on the accident date, it took 21 minutes to increase rpm from 60 to 72.) Additionally, according to the control system manufacturer, the maximum rpm could also be limited by a high engine load, potentially resulting in a lower speed than ordered by the operator.
